## **Appendix B**

### **Description and Photo-Documentation of Field Work Activities 2005-2007**

*February 2008*

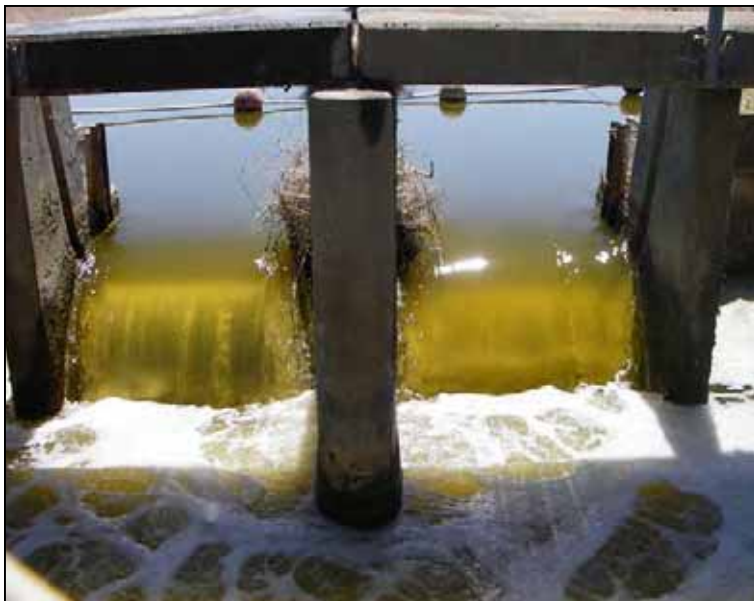
**DO-104 San Luis Drain Check 16**

Water flowing over a weir structure  
at a check station along the San Luis  
Drain.

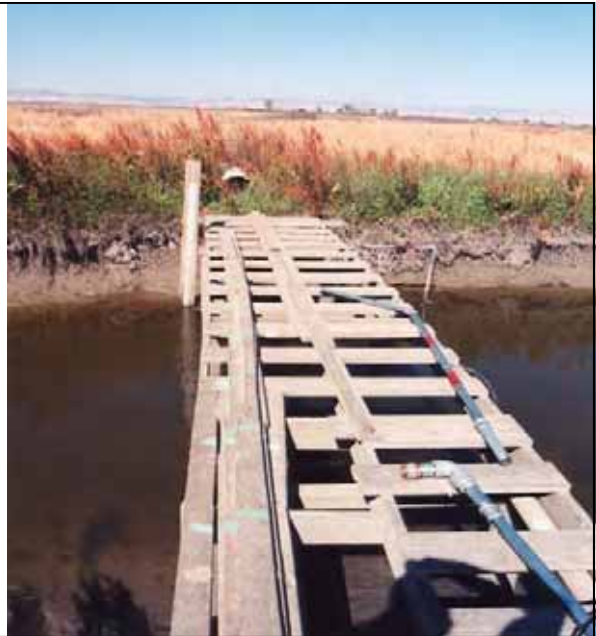
Picture showing the wood bridge over Los Banos Creek. The bridge was washed out in late 2005.

Sometimes natural events, such as storms, washed out a station. On January 9<sup>th</sup>, 2006 the sensors and bridge at DO-20 Los Banos Creek Flow Station were found washed out. The bridge was replaced by Grasslands Water District in March 2006 and the bubbler installed September 5<sup>th</sup>, 2006 and the Sontek installed October 31<sup>st</sup>, 2006. On Feb 2<sup>nd</sup>, 2006 DO-45 Volta Wasteway at Ingomar Grade the staff gauge was remounted on a metal pole because the first (wood) fixture had rotted out. The station at DO-57 Ramona Lake was washed out in the 2006 April floods and was repaired in March 2007. Occasionally there were problems with the wiper that cleans the optic sensors on the sonde used for sampling and extended deployments causing the wiper to park over the sensor and present invalid readings. This happened on September 7<sup>th</sup>, 2006 to one of the crews on a Core sampling event. On October 26<sup>th</sup>, 2006 the sonde used for sampling had the DO sensor membrane punctured and had to be replaced in the field.

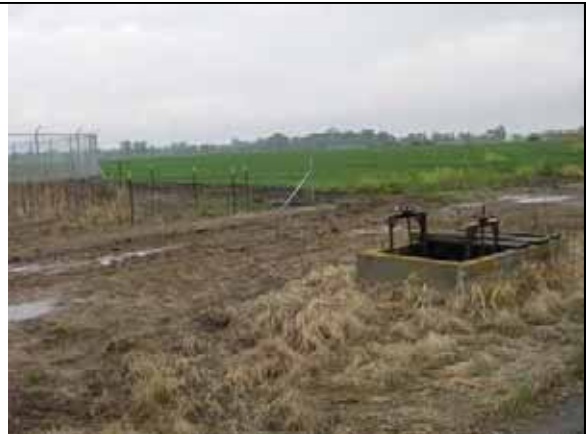
**DO-39 Salado Creek**

A segment of Salado Creek near the flow station flows underground through pipes and can be accessed by openings like the one pictured above.

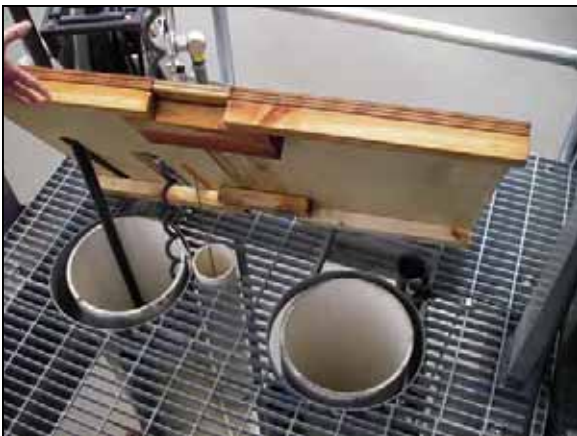
**DO-05 San Joaquin River at Vernalis**

Stilling wells for the instruments used by DWR at their Vernalis flow station.

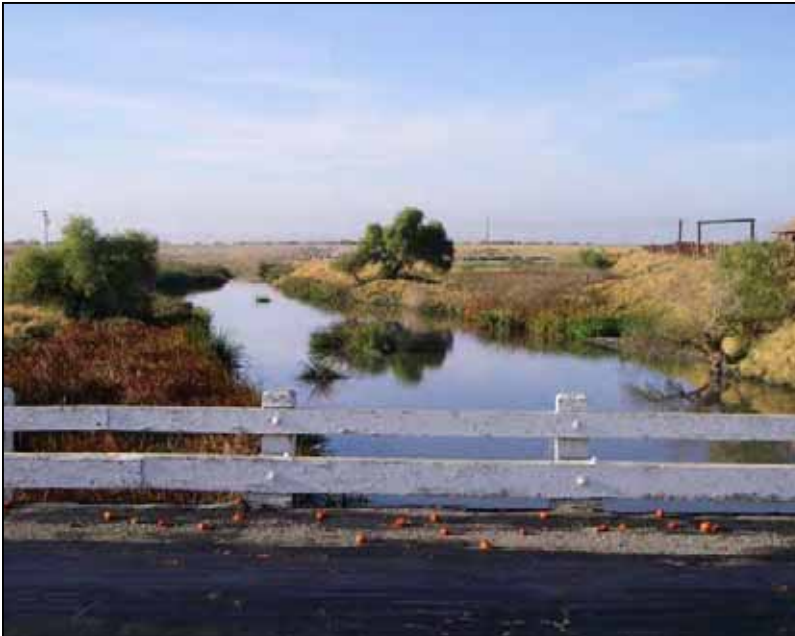
### **DO-53 Salt Slough at Wolfsen**

Sample location on Wolfsen bridge over Salt Slough. The EC cable was replaced at this site.

Performed maintenance on Westside stations. DO-35 Westley Wasteway, DO-33 Hospital Creek and DO-53 Salt Slough at Wolfsen were visited for data downloads, cleaning, flow, EC, and temperature QA. The Starflow was removed from Westley Wasteway to troubleshoot. Bubbler connector was leaking. It was reassembled and tested for leaks, but none were found.

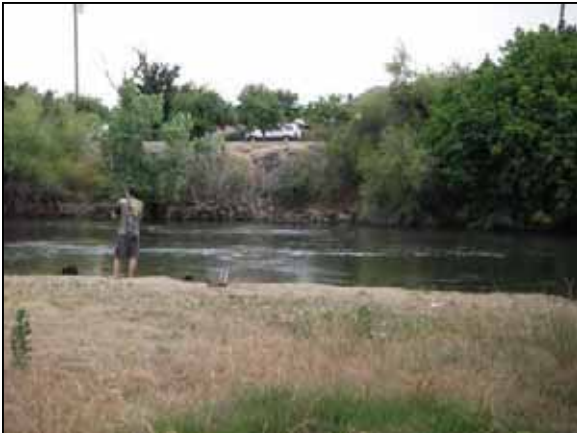
**DO-28 TID Westport Drain**

Westport Drain showing where old flow station had been washed out in the previous year.

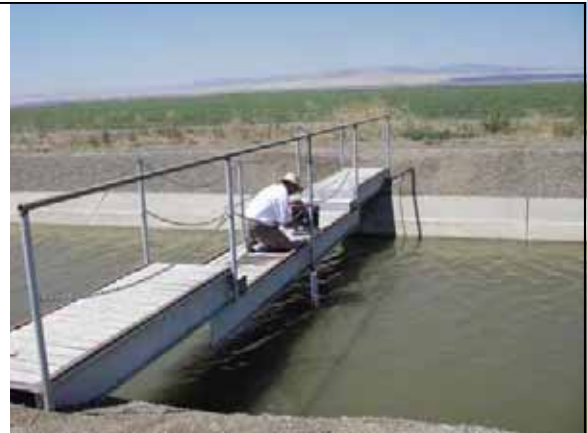
#### **DO-103 San Luis Drain Check 18**

Rhodamine dye was added to the San Luis Drain tinting the water with a red hue.

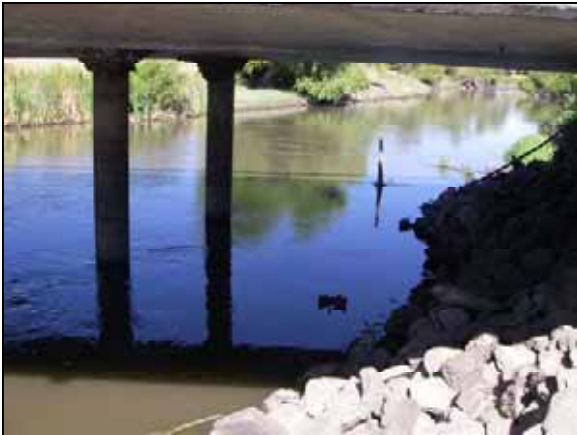
**DO-36 Del Puerto Creek.**

The photo is depicting the bubbler line, EC line, and staff gauge located in Del Puerto Creek.

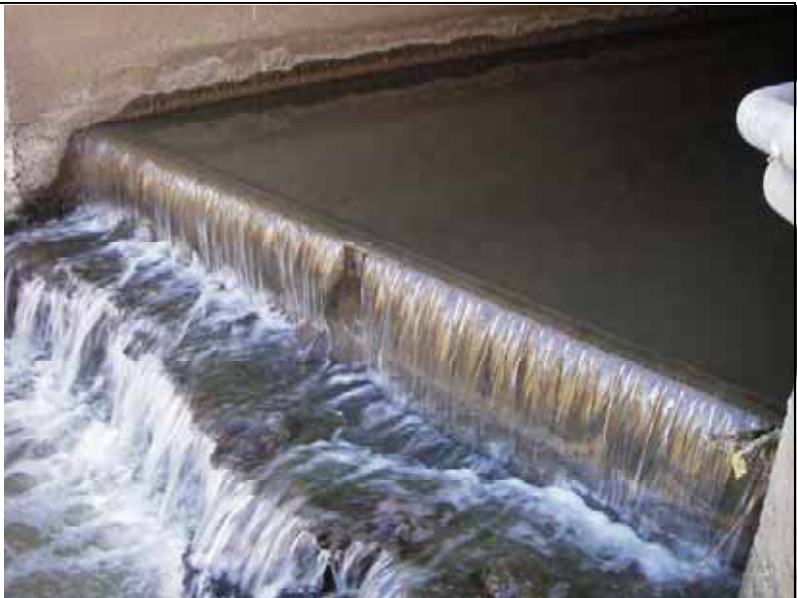
**DO-35 Westley Wasteway**  
Weir structure confining the water in a pond at Westley Wasteway.

**DO-34 Ingram Creek**  
Weir structure at DO-34 Ingram Creek.

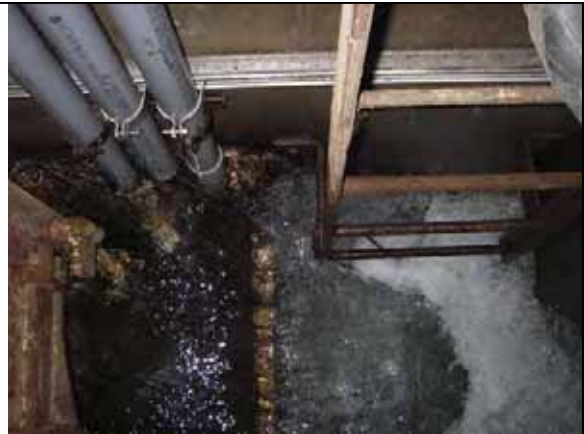
#### **DO-31 New Jerusalem Drain**

Weir structure, bubbler line, and EC probe in the bottom of the manhole at New Jerusalem Drain.

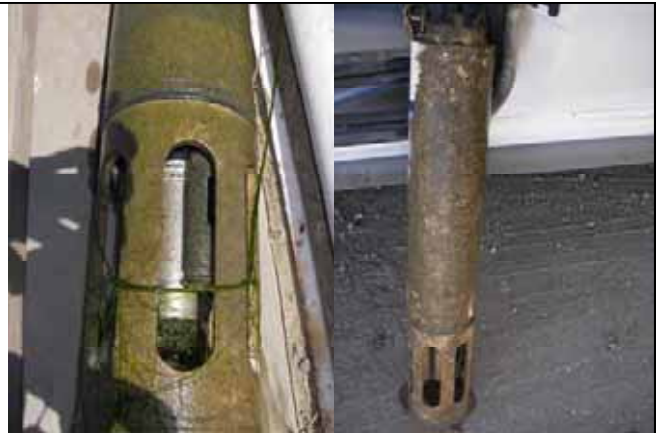
#### **DO-50 PE-14 Grasslands Area Farmers**

Pictures of a Hydrolab Multiprobe after being deployed in the headwaters to the San Luis Drain.

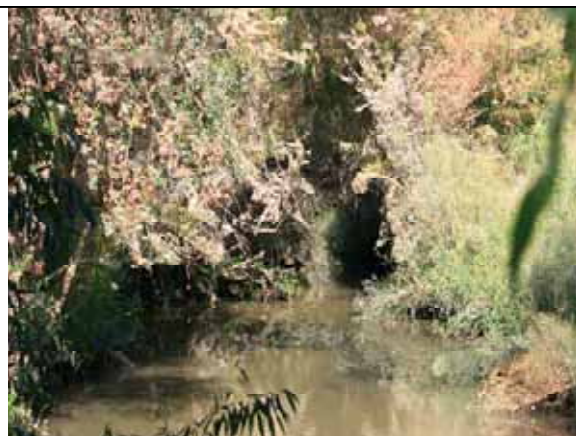
**DO-25 MID Miller Lake**  
Picture looking downstream of weir structure at Miller Lake.

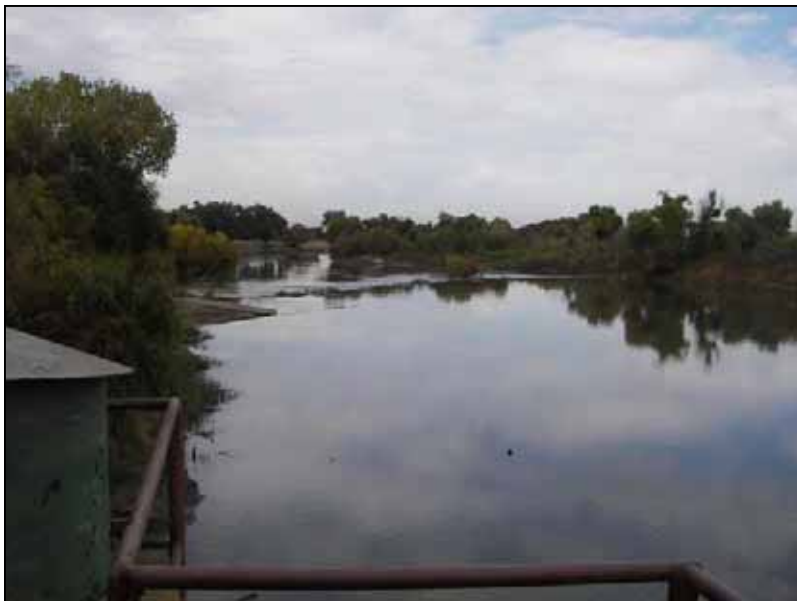
**DO-07 SJR at Patterson**  
Photo of the boat ramp and low water near the pump platform at Patterson.

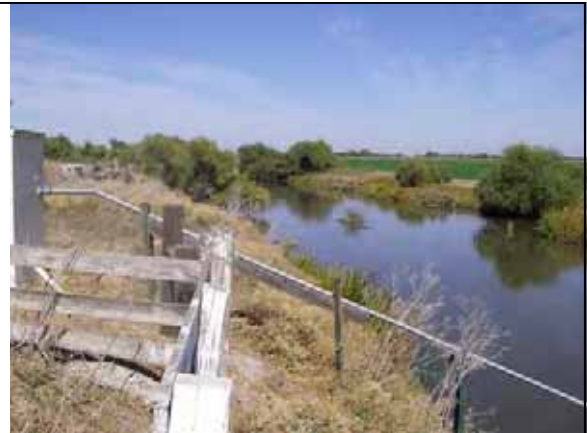
**DO-53 Salt Slough at Wolfsen**  
Flow station on Salt Slough at Wolfsen bridge.

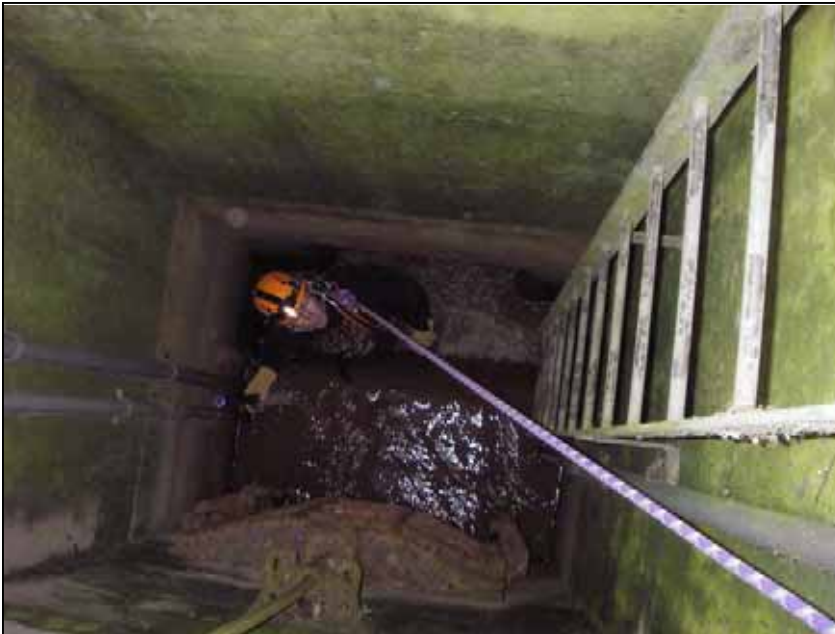
### **DO-38 Marshall Drain**

Chris Linneman (Summers Engineering) collecting stage and flow QA data from the bottom of the Marshall Drain manhole.

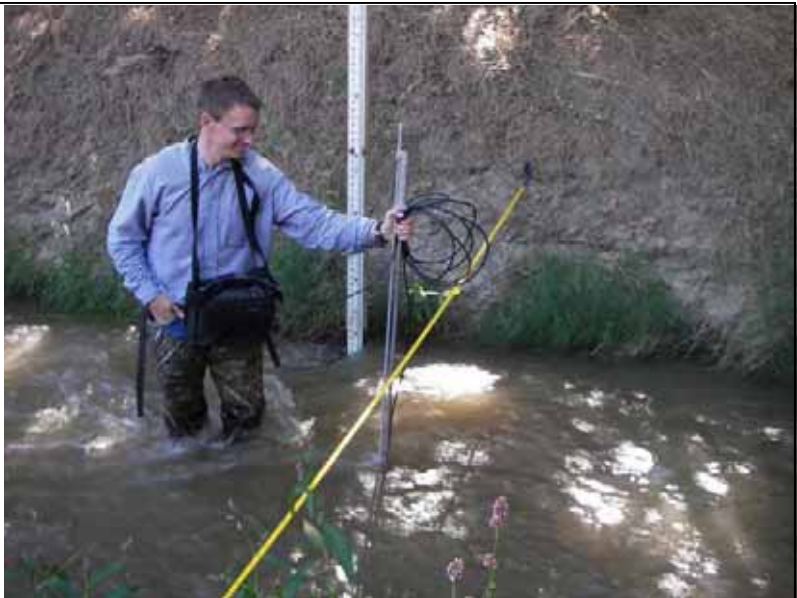
### **DO-36 Del Puerto Creek**

Chris Linneman performing a flow rating at Del Puerto Creek.

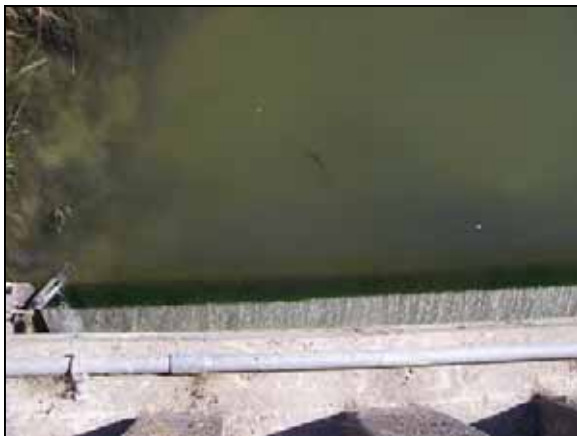
**DO-29 TID Harding Drain**

Water flowing over the weir structure in Harding Drain.

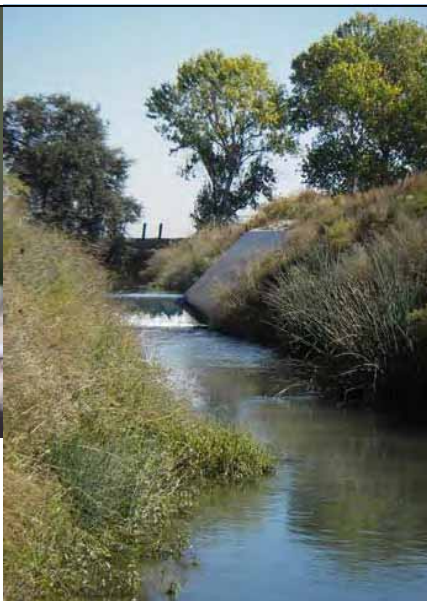
**DO-28 TID  
Westport Drain**

Water flowing through the concrete flume.

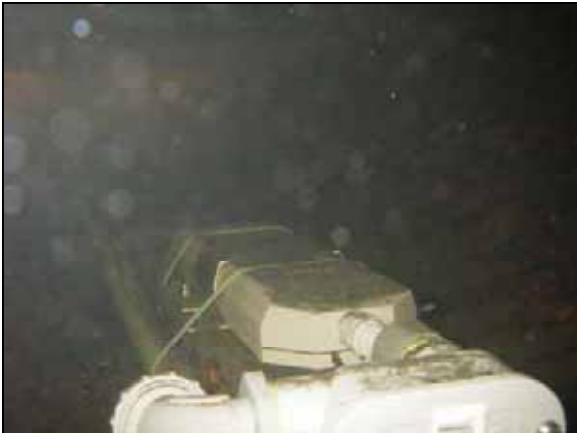
**DO-62 Mallard Slough**

Underwater picture of the newly installed Starflow unit at DO-62 Mallard Slough.

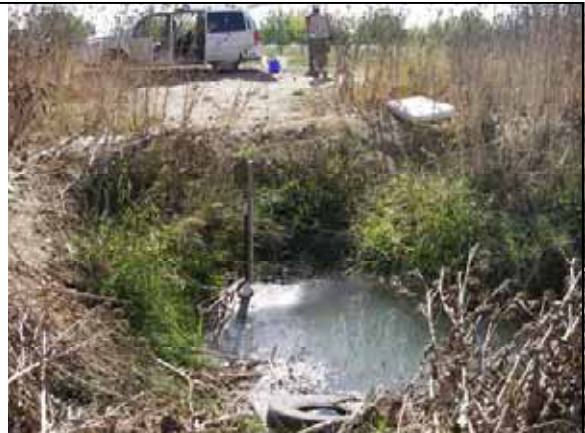
**DO-35 Westley Wasteway**

Westley Wasteway just upstream of the flow station.

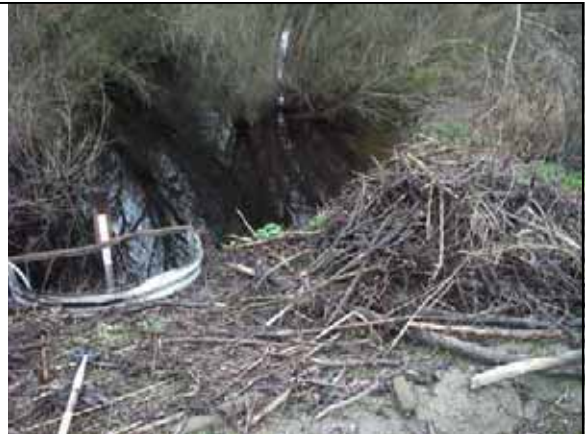
**DO-60 Moffit 1 South**  
Beaver debris often clogs up the weir structure which has to be cleared.

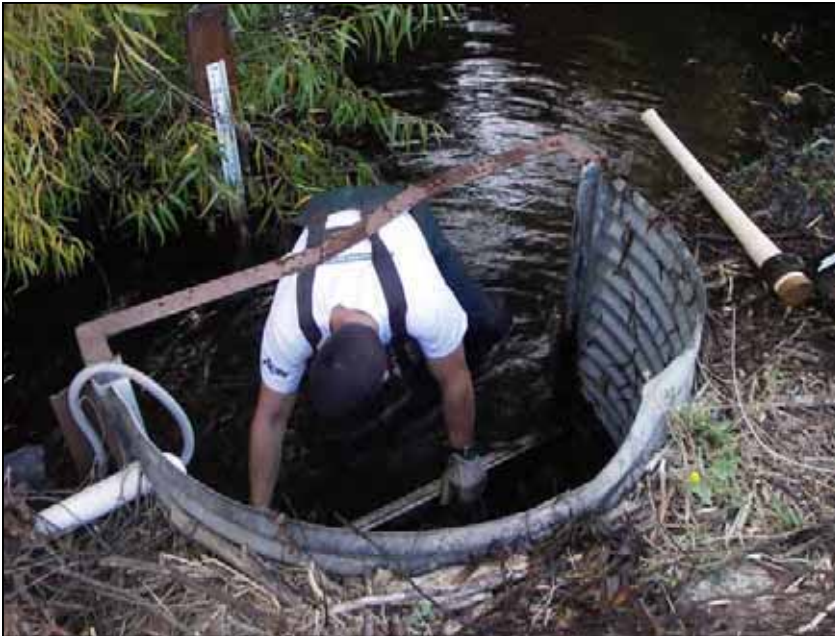
**DO-60 Moffit 1 South**  
Jesse Merkel cleaning off the weir boards.

Sampling for wetland sites. Weir boards at DO-60 Moffit 1 South were cleared and the data was downloaded from the station.

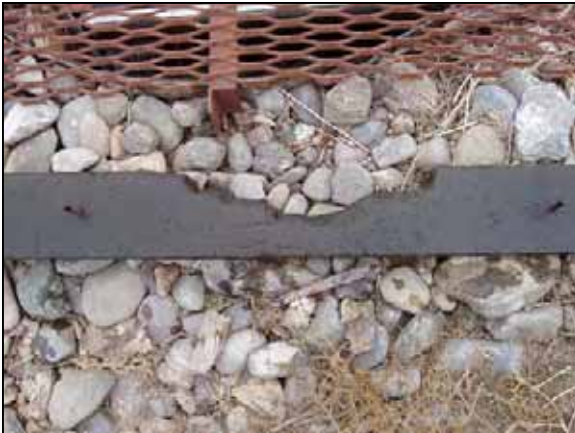
### **DO-62 Mallard Slough**

Photo of what the beavers will do to a weir board if the top is not encased in a metal bracket.

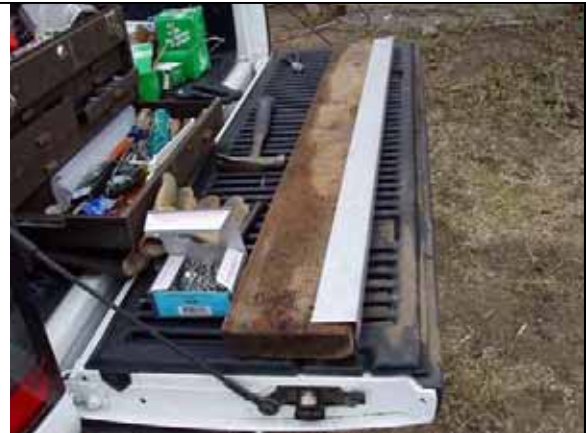
### **DO-60 Moffit 1 South**

Metal brackets were added to the weir boards to prevent the beavers from chewing the boards.

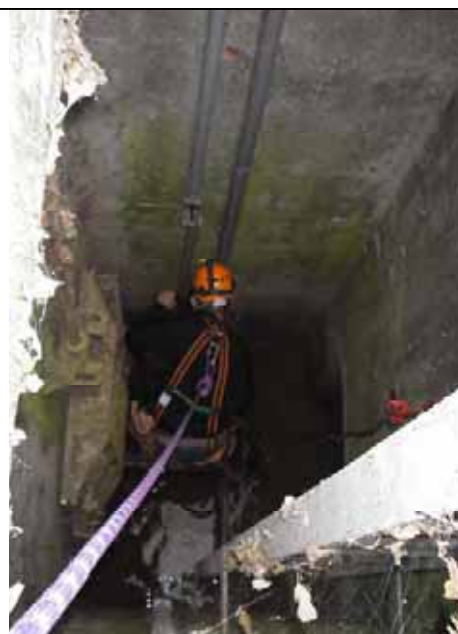
**DO-64 Moran Drain**  
Chris Linneman  
(Summers Engineering)  
drilling anchors into the  
concrete to stabilize  
bubbler pipe.

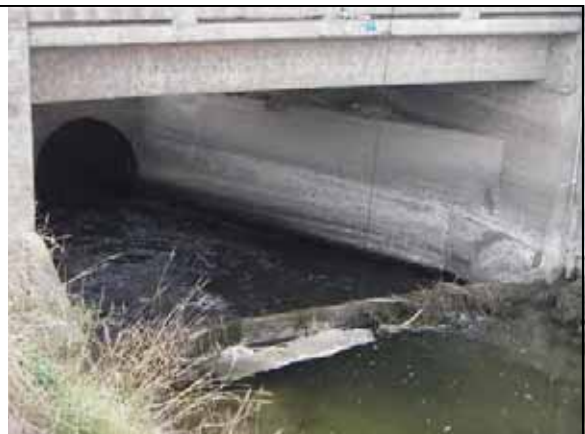
**DO-29 TID Harding Drain**

Water is flowing through a hole in the middle of the weir structure instead of over the top.

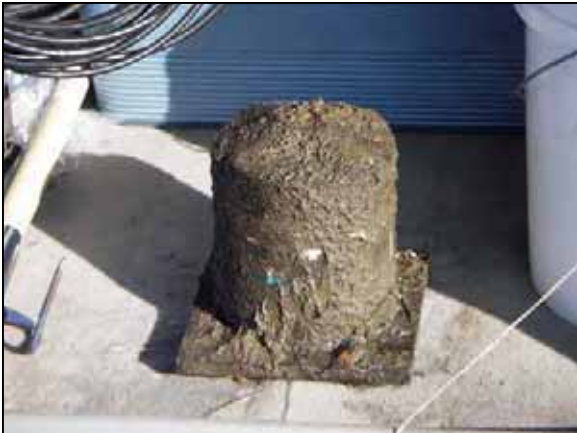
**DO-53 Salt Slough at Wolfsen**

Picture of the SonTek after being deployed in Salt Slough for a length of time.

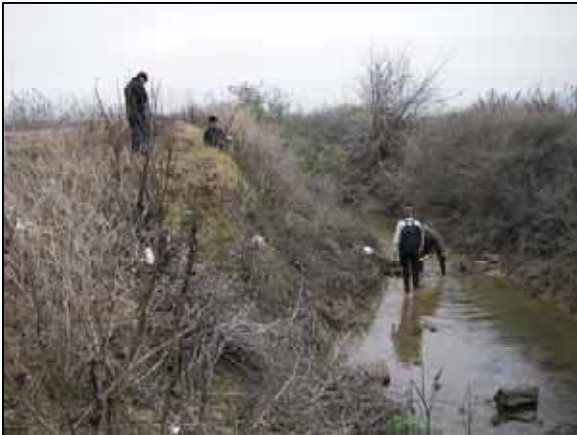
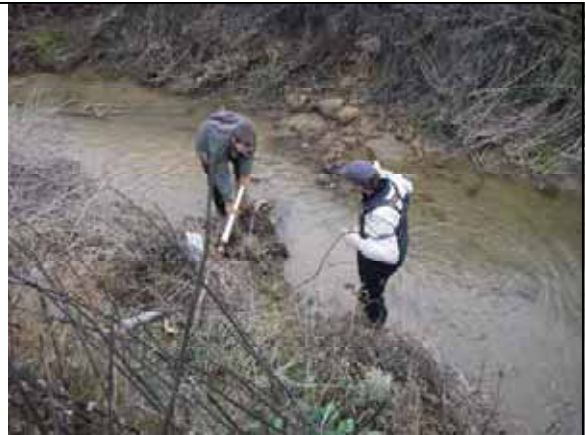
### **DO-34 Ingram Creek**

(left) Student Intern, Kyle Kearney, Jeremy Hanlon, and Chris Linneman removing EC probe which had been encased in sediment. (right) Chris and Jeremy clearing away sediment buildup.

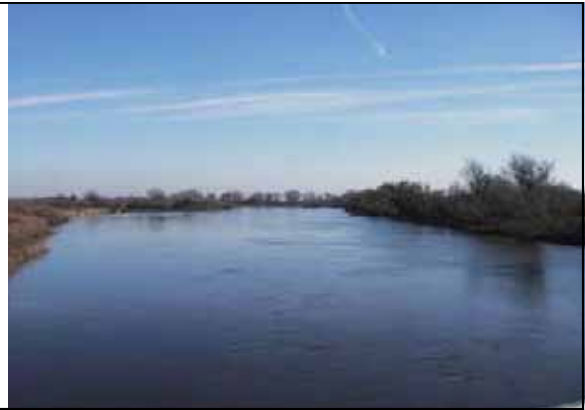
Sampling for core sites. Picture taken from DO-05 SJR at Vernalis from the Department of Water Resources (DWR) McClune station platform looking north, shows San Joaquin River (SJR) swollen with runoff from recent rains.

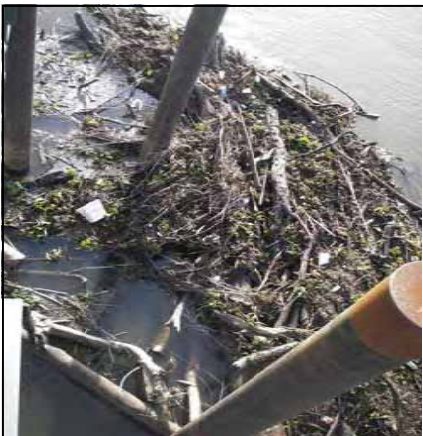
**DO-05 SJR at Vernalis**

Debris caught on DWR platform pylons.

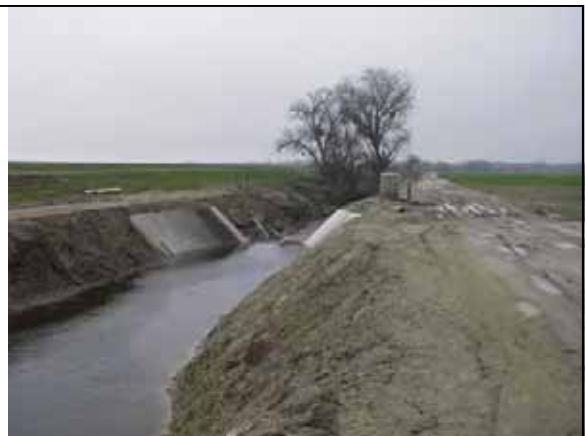
**DO-28 TID Westport Drain Flow station**

Newly Installed flume and SCADA monitoring system, about 300 ft downstream of the previous station location.

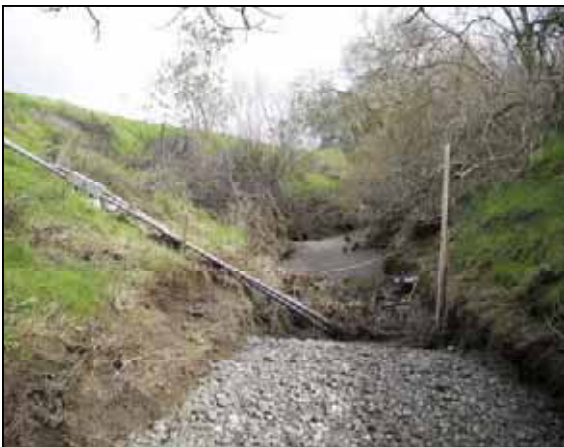
**DO-36 Del Puerto Creek monitoring site**

Streambed is dry despite recent rains and high levels in SJR.

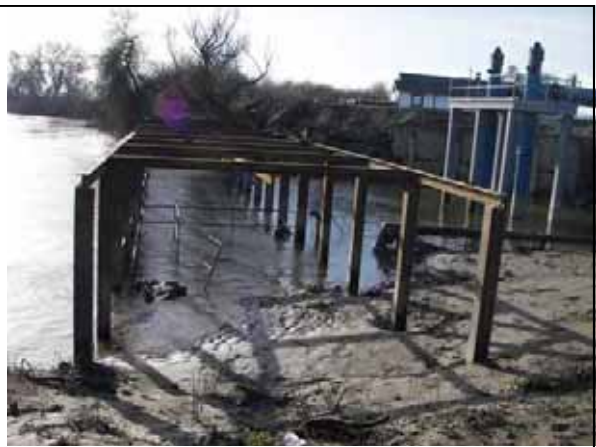
**DO-06 SJR at Maze Blvd.**

El Solyo pump platform submerged under swollen SJR.

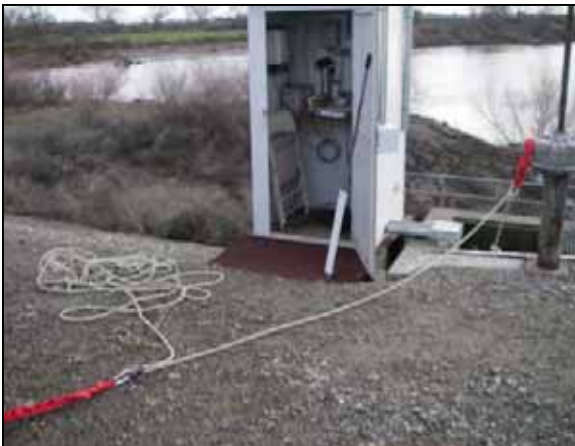
### DO-31 New Jerusalem Drain

(left) Station house on top of levee with SJR behind. Ropes are rigged for lowering or belaying confined space entrant. (right) Rope system rigged for hauling up of confined space entrant.

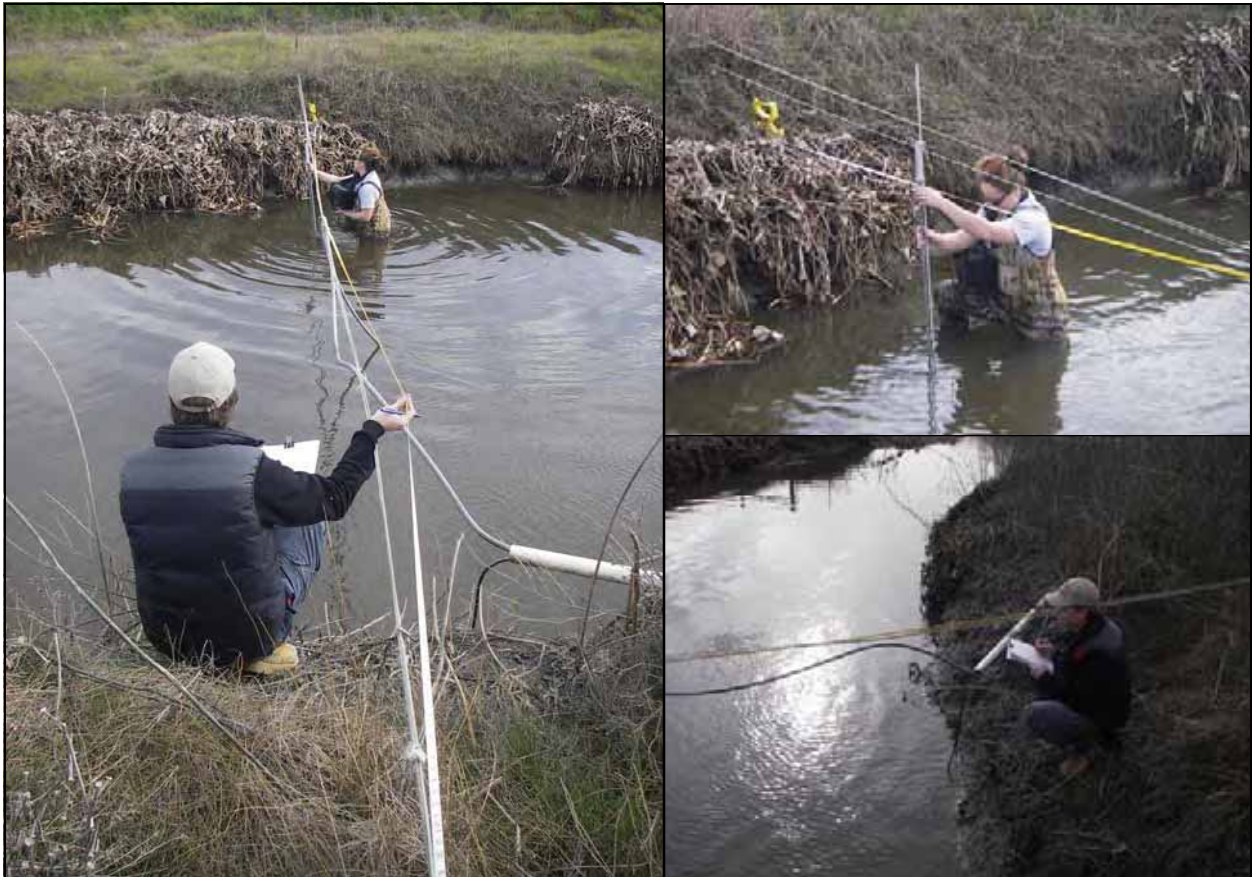
Met with Lara Sparks (Grasslands Water District/Department of Fish and Game) to assist her with stream ratings and QA at the DO sites she manages within the Grasslands water district. DO-45 Volta Wasteway Flow station staff gauge had been mounted to wood post that rotted away. The staff gauge was re-installed and anchored directly to a pole on the bridge with stainless steel clamps.

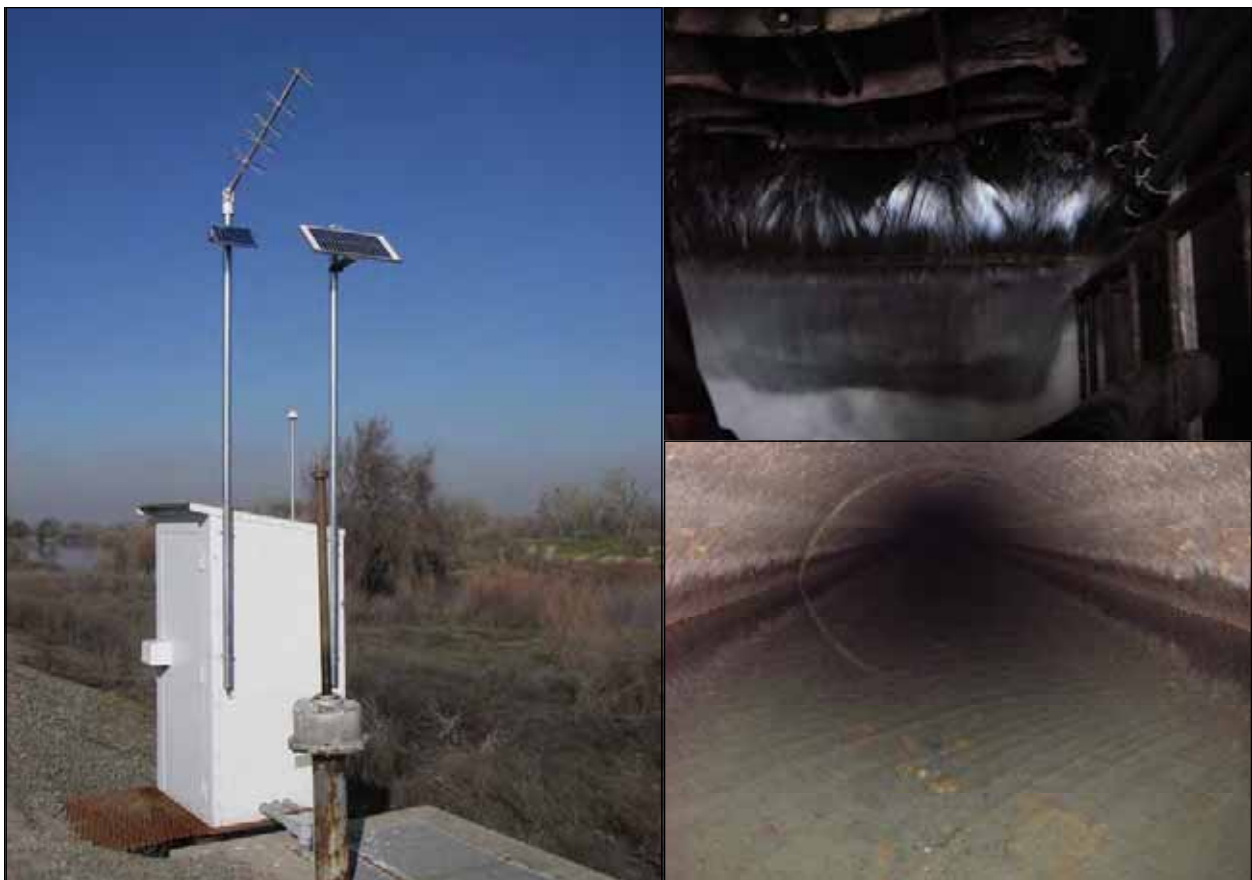
#### **DO-31 New Jerusalem Drain**

Installed new MACE Agriflow Doppler flow meter. Note new smaller solar panel in picture (left) provides 6V power supply for Agriflo unit. Picture of water flowing over weir boards (top right) and picture looking upstream of pipe under levee (bottom right).

Returned to DO-31 New Jerusalem Drain to update Firmware on new MACE Agriflo unit so it would correctly output SDI-12 to the DA logger.

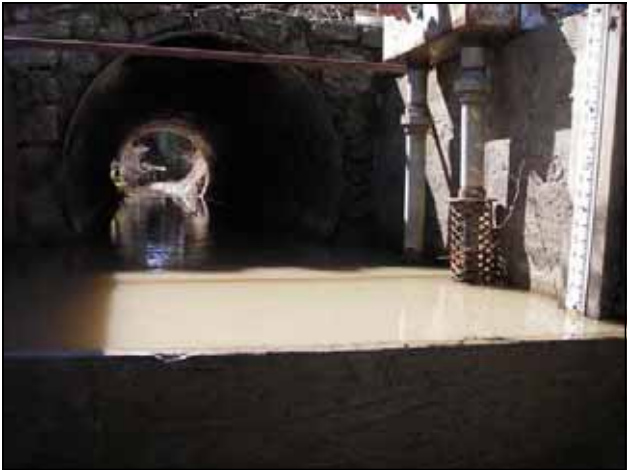
**DO-33 Hospital Creek**

Close-up photo of installation showing bubbler pipe, EC meter in cage, and stream gauge all just upstream of weirboard.

Accompanied Kyle Kearney (Tetra Tech) to provide support for safe entry into confined spaces. Took flow measurements. Added one 2x8 board to each of the three drains sites DO-38 Marshall Road Drain, DO-64 Moran Drain, and DO-65 Spanish Grant Drain. DO-34 Ingram creek, repositioned rocks in stream to help avoid siltation of EC probe.
